Structural Health Monitoring of a Five-Story Reinforced Concrete School Building in Preparation for the Upcoming West Valley Fault Movement using USHER Technology

Public school buildings are very essential in times of calamities because it serves as one of the evacuation facilities in the Philippines. In preparation for the upcoming movement of west valley fault line that will cause a major destruction of lives and properties in metro manila, this study aims to conduct a structural health monitoring on a five-story school building by the aid of wireless smart sensor and conducting capacity spectrum method. The sensor was installed on the ground floor of the building as stated on the national structural code of the Philippines. In addition to this, the second sensor was installed on the top most floor of the building to record the data experience by the structure itself. After the installation, the actual reading on the ground are 0.00196159g on longitudinal, 0.002137g on transverse, and 0.00206172g on vertical direction. The actual reading on the structure are 0.00221014g on longitudinal, 0.00192106g on transverse, and 0.00214517g on vertical direction. Compare to the 0.3g peak gr

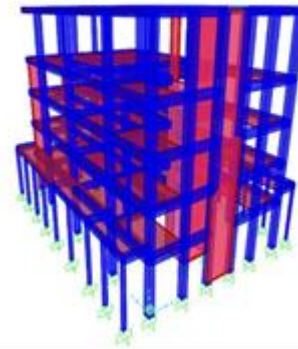
Figure 2. Structural Model

The first step is creating a realistic structural model of the five-story reinforced concrete school building using SAP2000 software. The supports in the foundation was assumed to be fixed. The distance of the building to the west valley fault is 93km and the area on which the building was located has a high percentage of liquefaction based from the data provided by the Philippine Institute of Volcanology and Seismology. The final structural model was shown in figure 2.

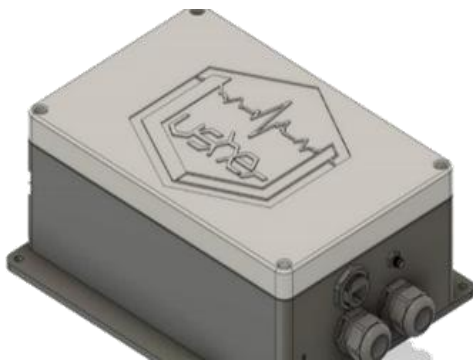
Figure 3. USHER Sensor

The development of sensors is made by the USHER team in the Philippines. The sensor as shown in the figure, reads the natural frequency of the building in three direction; transverse, longitudinal, and vertical direction. The sensor is located at the ground floor/lowest basement of the building as illustrated in the national structural code of the Philippines.

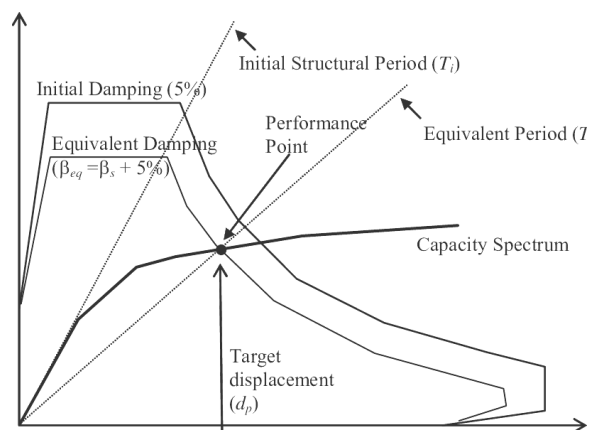
Figure 5. Capacity Spectrum Method

This method will estimate the displacement and forces experienced by the structure on its non-linear state. Through simulating the non-linear push over analysis, maximum displacement and base shear was illustrated in the push over curve. Performance points on intersecting to the push over curve was gathered after incorporating the ground motions.

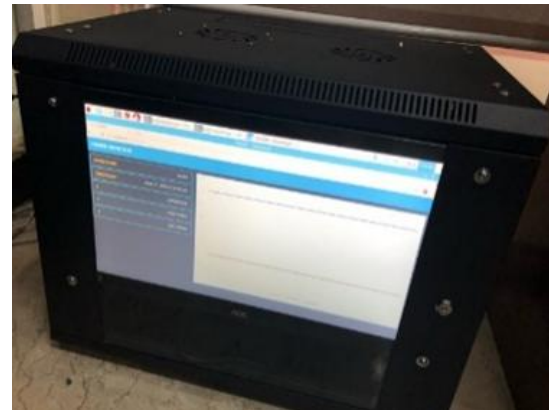
Fig. 6. Installed Sensor

The figure shows the actual installation of the sensor on the ground level of the school building. It is enclosed by the cage with a monitor in the front that shows the real time frequency reading of the ground. The cage serves as a protection on the sensor so that unappropriated reading will be avoided. The screen on the front of the cage displays the three dimensional frequency reading. The threshold is directly programmed on the portal.

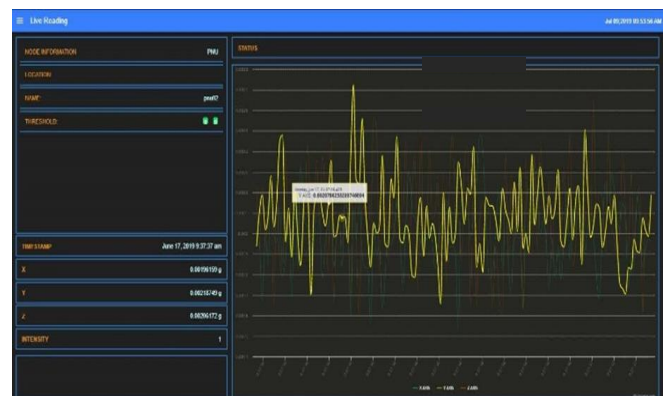
Fig. 7. Usher Portal Reading on the Ground

The figure shows the usher portal interface which displays the longitudinal, transverse, and vertical frequency reading on the ground, the values are 0.00196159g, 0.002137g, and 0.00206172g respectively. The intensity was also displayed; this was in accordance to the Philippine earthquake intensity scale.

Ground:

x	0.00196159g
y	0.002137g
z	0.00206172g

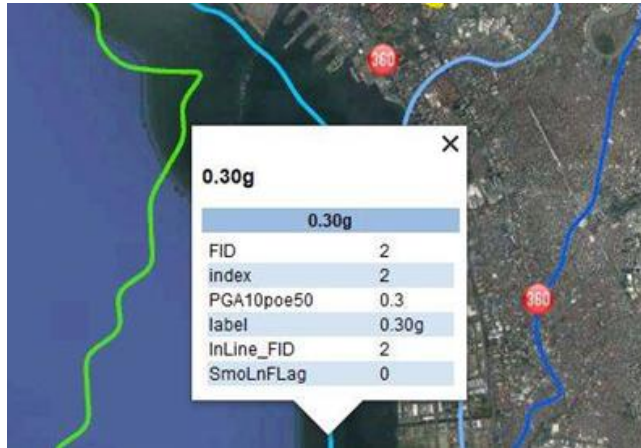
Fig. 9. PGA on the Building Location

Based from the peak ground acceleration map of metro manila from Philippine Institute of

Volcanology and Seismology (PhiVOLCS) atlas, the location of the building falls on the boundary with 0.3g peak ground acceleration. This value will be compared on the actual reading, and also this serves as the threshold pre, during, and after earthquake.

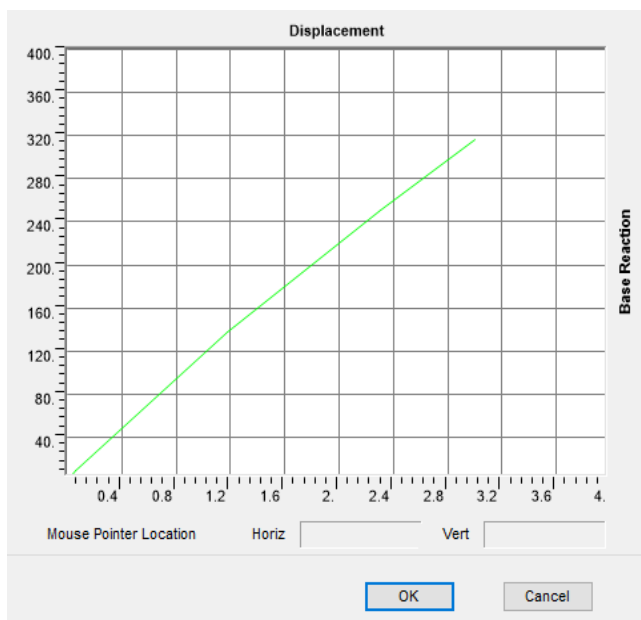
Fig. 10. Push over Curve

The maximum displacement on the linear state was 0.061191mm (dy) while 3.001595mm (du) for the non-linear state.

Displacement (mm)	Base Force (KN)
	0	0
dy	0.061191	8.48
	1.177824	137.923
du	2.306619	250.724
	3.001595	316.657

The dy and du was used in determining the limits in charactrizing the different level of damage.

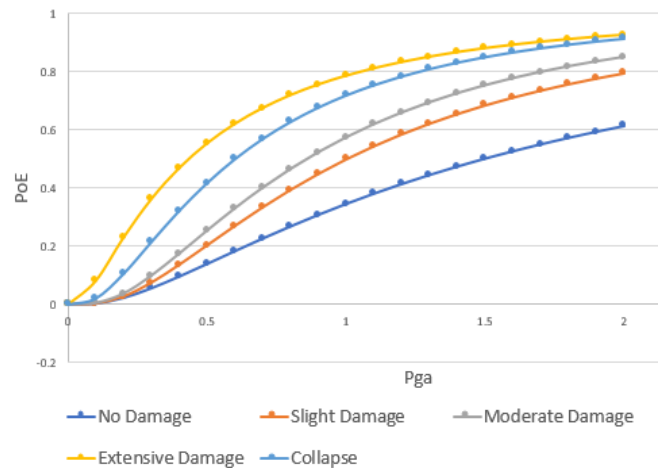
Fig. 11. Fragility Curve at X- Axis

Push over analysis and capacity spectrum method was analyzed to get the upper and lower limit of ground acceleration to consider in levelling the damage state. These damage states was used in identifying the probability of exceedance and its corresponding peak ground acceleration through fragility curve analysis in this equation: M. Shinozuka (2001)

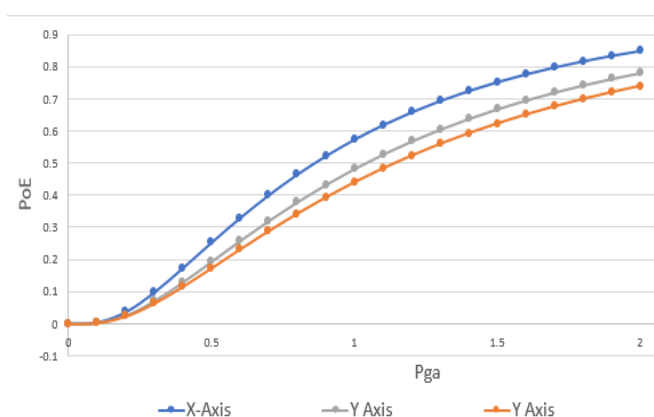
Fig. 14. Fragility Curve of Moderate Damage in Three Direction

At 10% probability of exceedance for moderate damage, the threshold on the structure are:

x : 0.3071g
y : 0.3725g
z : 0.35g

The actual reading on the structure are 0.00221014g on longitudinal, 0.00192106g on transverse, and 0.00214517g on vertical direction. Comparing to the threshold obtained from capacity spectrum and fragility curves analysis, at 10% probability of exceedance on moderate damage, which are 0.3071g on longitudinal, 0.3725g on transverse, and 0.35g on vertical direction. The current acceleration experienced by the structure does not exceed the threshold which conclude that the structure is safe.
